## Annual Inspection

East Hertfordshire District Council

Horses Meadow (Little Munden PC)

Horse's Meadow, Dane End, Copied to Little Munden PC,  
SG12 0LS

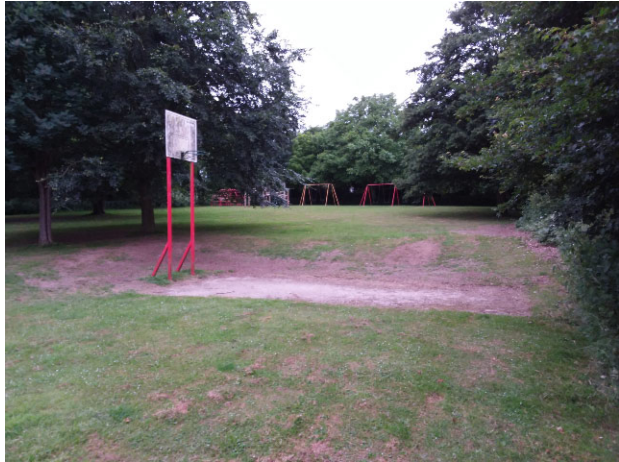
**Item:** Ancillary Items - Site General  
**Manufacturer:** Owner/Operator  
**Surface Type:** N/A  
**Equipment Compliance:** N/A  
**Surface Area Compliance:** N/A  
**Ref/Part Number:**  
**Total Findings:** 1

It is recommended that information signs with emergency contact details are installed at each entrance/exit point to the playground - Provide in accordance with the recommendations set out in BS EN 1176

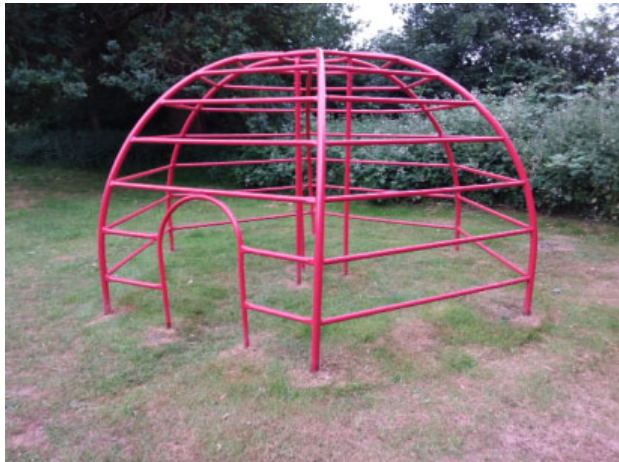
**Item:** Activity Equipment - Climbing Frame  
**Manufacturer:** Wicksteed Playgrounds  
**Surface Type:** Grass Matrix Tiles  
**Equipment Compliance:** Yes  
**Surface Area Compliance:** Yes  
**Ref/Part Number:**  
**Total Findings:** 1

Parts of the steel on this item have corroded excessively and the metal has perforated in places - Ensure all affected areas are treated and repaired

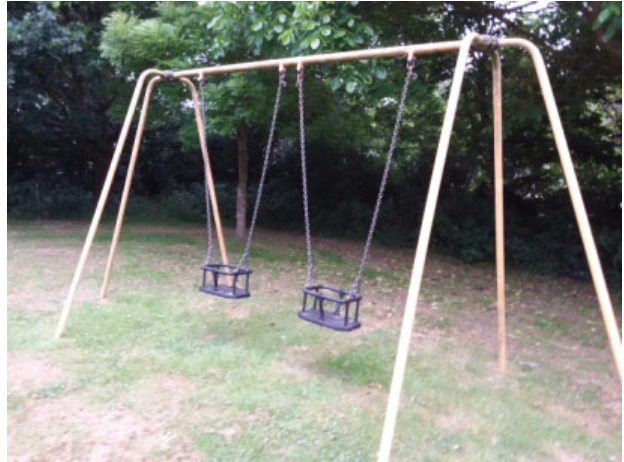
**Item:** Swings - 1 Bay 2 Seat (Cradle)  
**Manufacturer:** Wicksteed Playgrounds  
**Surface Type:** Grass Matrix Tiles  
**Equipment Compliance:** Yes  
**Surface Area Compliance:** Yes  
**Ref/Part Number:**  
**Total Findings:** 1

There is algae or moss on the surface of the equipment - Clean and treat appropriately

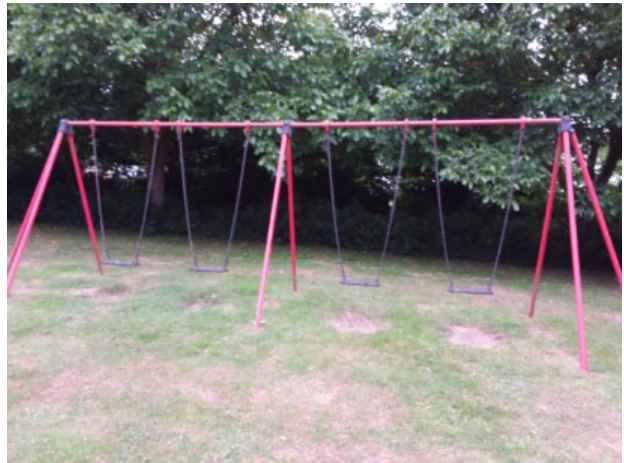
**Item:** Swings - 2 Bay 4 Seat (Flat)  
**Manufacturer:** Wicksteed Playgrounds  
**Surface Type:** Grass Matrix Tiles  
**Equipment Compliance:** No  
**Surface Area Compliance:** Yes  
**Ref/Part Number:**  
**Total Findings:** 3

The grass mats are silted up and the soil is compacted; this may have an effect on the impact absorbing properties of the surface - Lift and relay mats or test impact absorbing properties to ensure the correct surface qualities are maintained for the equipment

The seat is damaged and requires replacing - Replace damaged seat

The chain openings are in excess of the 8.6mm as recommended by BS EN 1176 - Monitor use

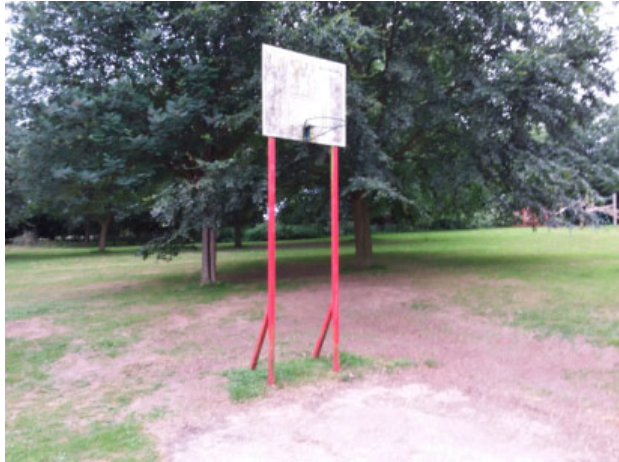
**Item:** Multi Use Games Area - Basket Ball Goal  
**Manufacturer:** Wicksteed Playgrounds  
**Surface Type:** Concrete  
**Equipment Compliance:** Yes  
**Surface Area Compliance:** N/A  
**Ref/Part Number:**  
**Total Findings:** 2

A clearly visible sign should be provided in a prominent position with the wording as detailed BS EN 15312- the equipment is not intended for children less than 3 years old- the warning Do not climb on the framework or nets- the warning Do not hang on the ring (if provided)- the warning Do not wear rings or other jewellery- name and telephone number of the administrator- number to call in case of accident - Monitor

There is/are several inserts missing - Replace missing inserts

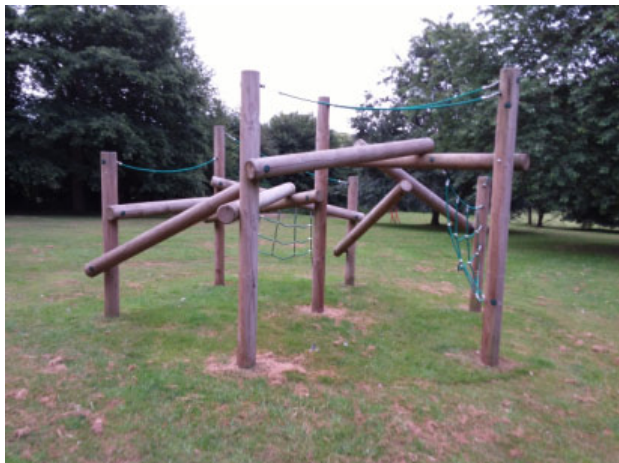
**Item:** Activity Equipment - Log Climber  
**Manufacturer:** Wicksteed Playgrounds  
**Surface Type:** Grass Matrix Tiles  
**Equipment Compliance:** Yes  
**Surface Area Compliance:** Yes  
**Ref/Part Number:**  
**Total Findings:** 1

The timber has a number of splits (shakes) although these are not considered to be a problem at present - Monitor to ensure the splits do not cross through fixing points of the structure and cause any instability

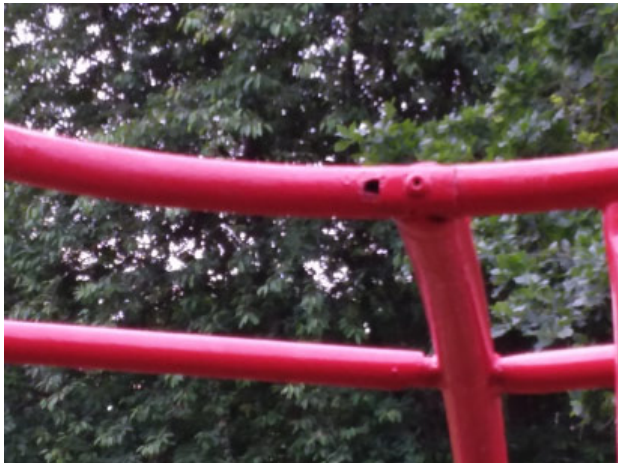
<b>6 - Low Risk (Finding 1)</b>			
<b>Item:</b>	Activity Equipment - Climbing Frame	<b>Risk Level:</b>	L - Low Risk
<b>Manufacturer:</b>	Wicksteed Playgrounds	<b>Surface:</b>	Grass Matrix Tiles

<b>Finding:</b>	Parts of the steel on this item have corroded excessively and the metal has perforated in places		<b>Action:</b> Ensure all affected areas are treated and repaired

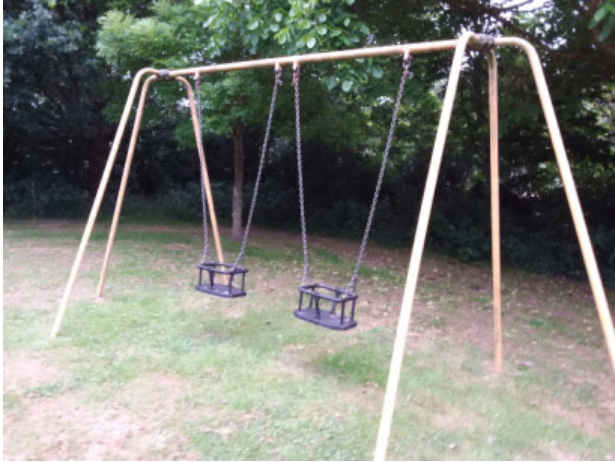
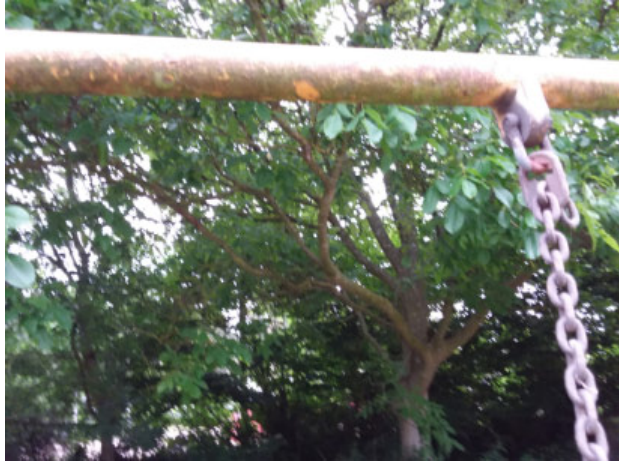
**6 - Low Risk (Finding 1)**

**Finding:** There is algae or moss on the surface of the equipment

**Action:** Clean and treat appropriately

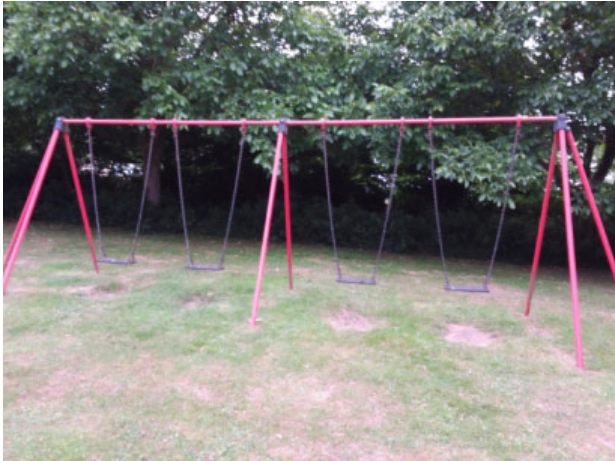
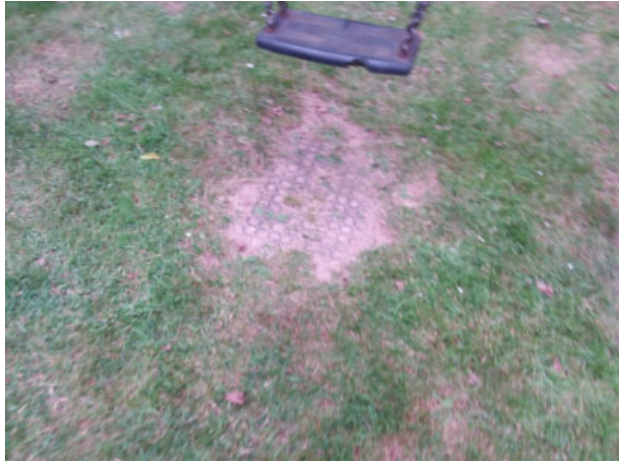
**8 - Low Risk (Finding 1)**

**Finding:** The grass mats are silted up and the soil is compacted; this may have an effect on the impact absorbing properties of the surface

**Action:** Lift and relay mats or test impact absorbing properties to ensure the correct surface qualities are maintained for the equipment

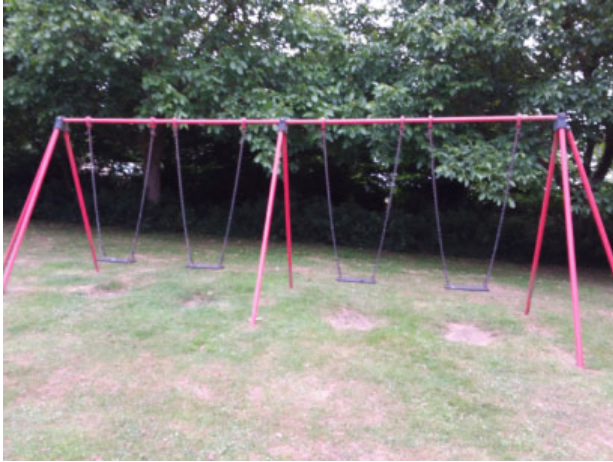
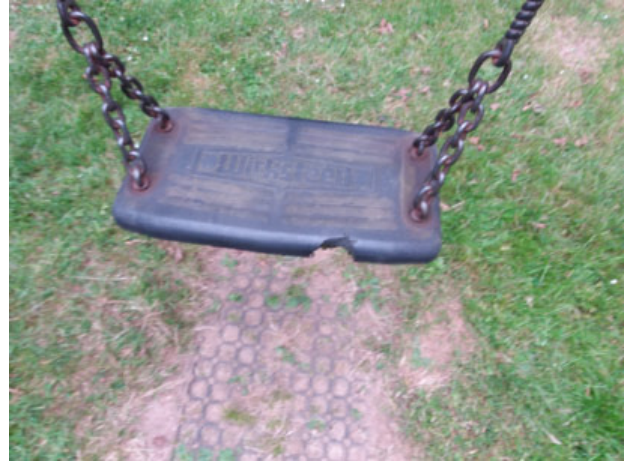
8 - Low Risk (Finding 2)

**Finding:** The seat is damaged and requires replacing

**Action:** Replace damaged seat

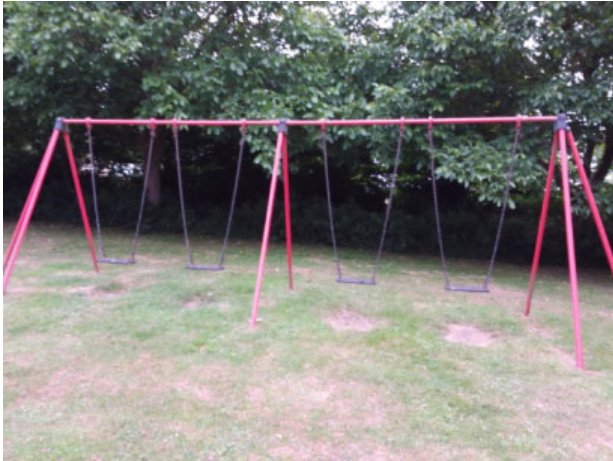
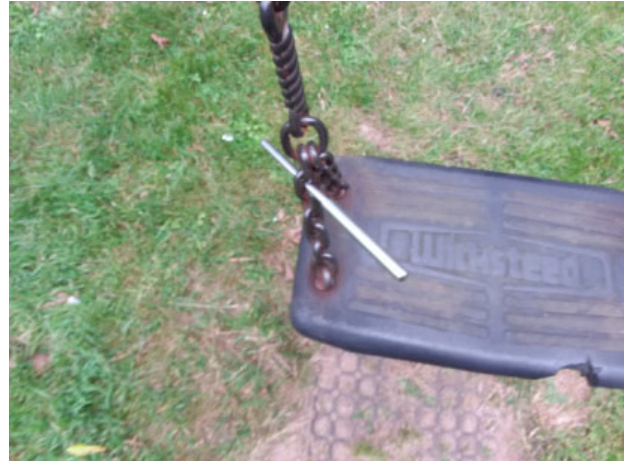
5 - Very Low Risk (Finding 3)

**Finding:** The chain openings are in excess of the 8.6mm as recommended by BS EN 1176

**Action:** Monitor use

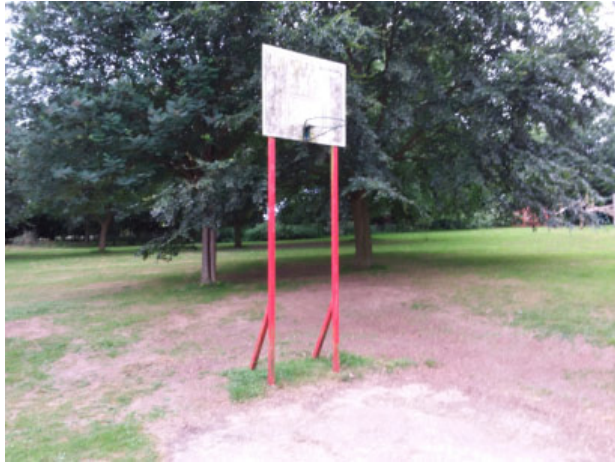
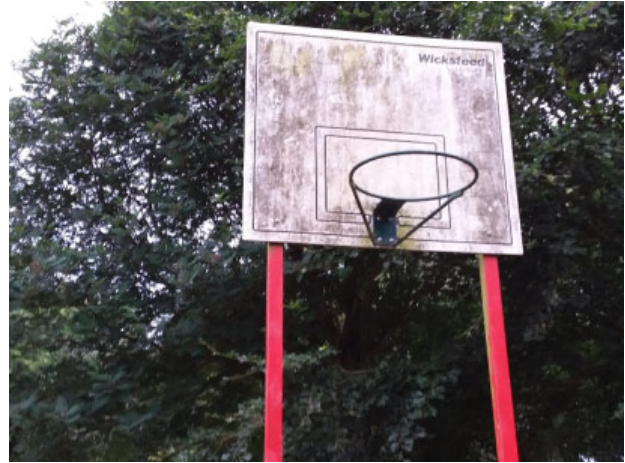
5 - Very Low Risk (Finding 1)

**Finding:** A clearly visible sign should be provided in a prominent position with the wording as detailed BS EN 15312- the equipment is not intended for children less than 3 years old- the warning Do not climb on the framework or nets- the warning Do not hang on the ring (if provided)- the warning Do not wear rings or other jewellery- name and telephone number of the administrator- number to call in case of accident

**Action:** Monitor

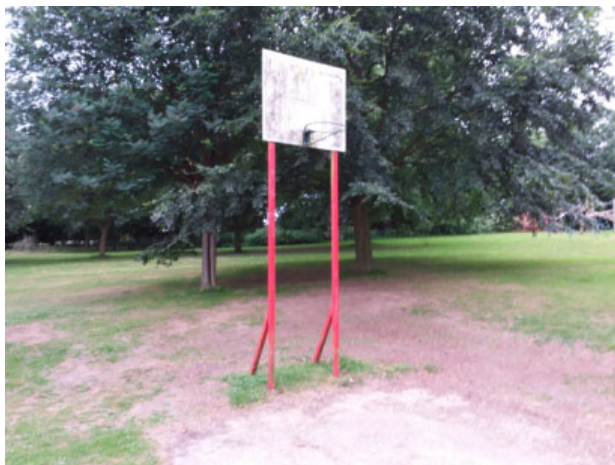
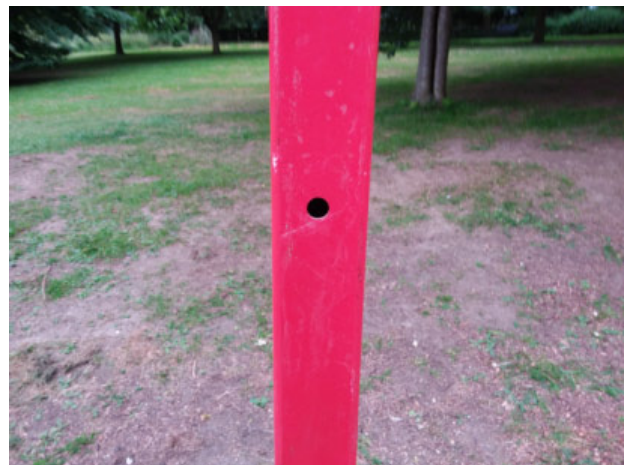
4 - Very Low Risk (Finding 2)

**Finding:** There is/are several inserts missing **Action:** Replace missing inserts

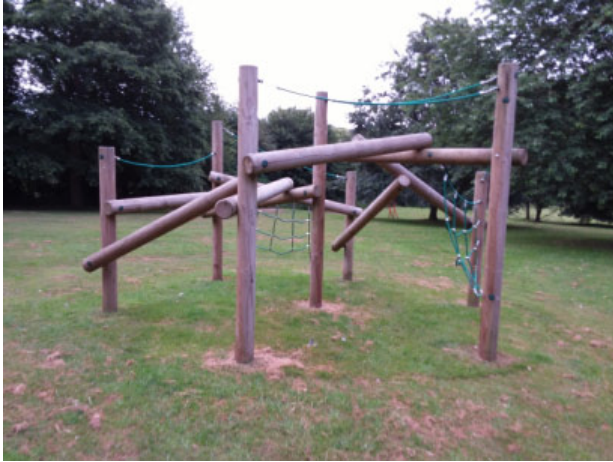
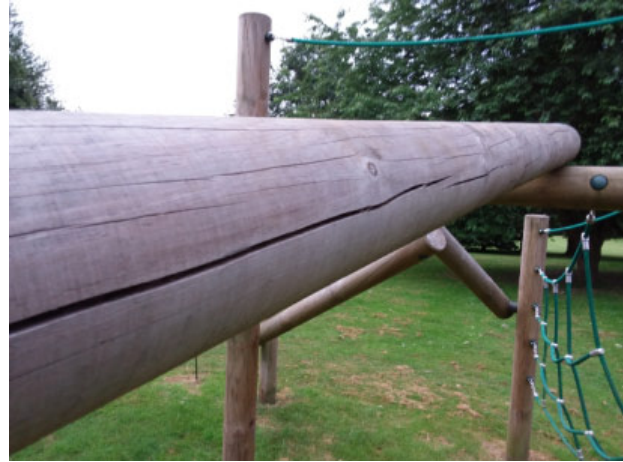
6 - Low Risk (Finding 1)

**Finding:** The timber has a number of splits (shakes) although these are not considered to be a problem at present

**Action:** Monitor to ensure the splits do not cross through fixing points of the structure and cause any instability
