## Annual Inspection

East Hertfordshire District Council

Horses Meadow (Little Munden PC)

Horse's Meadow, Dane End, Copied to Little Munden PC,  
SG12 0LS

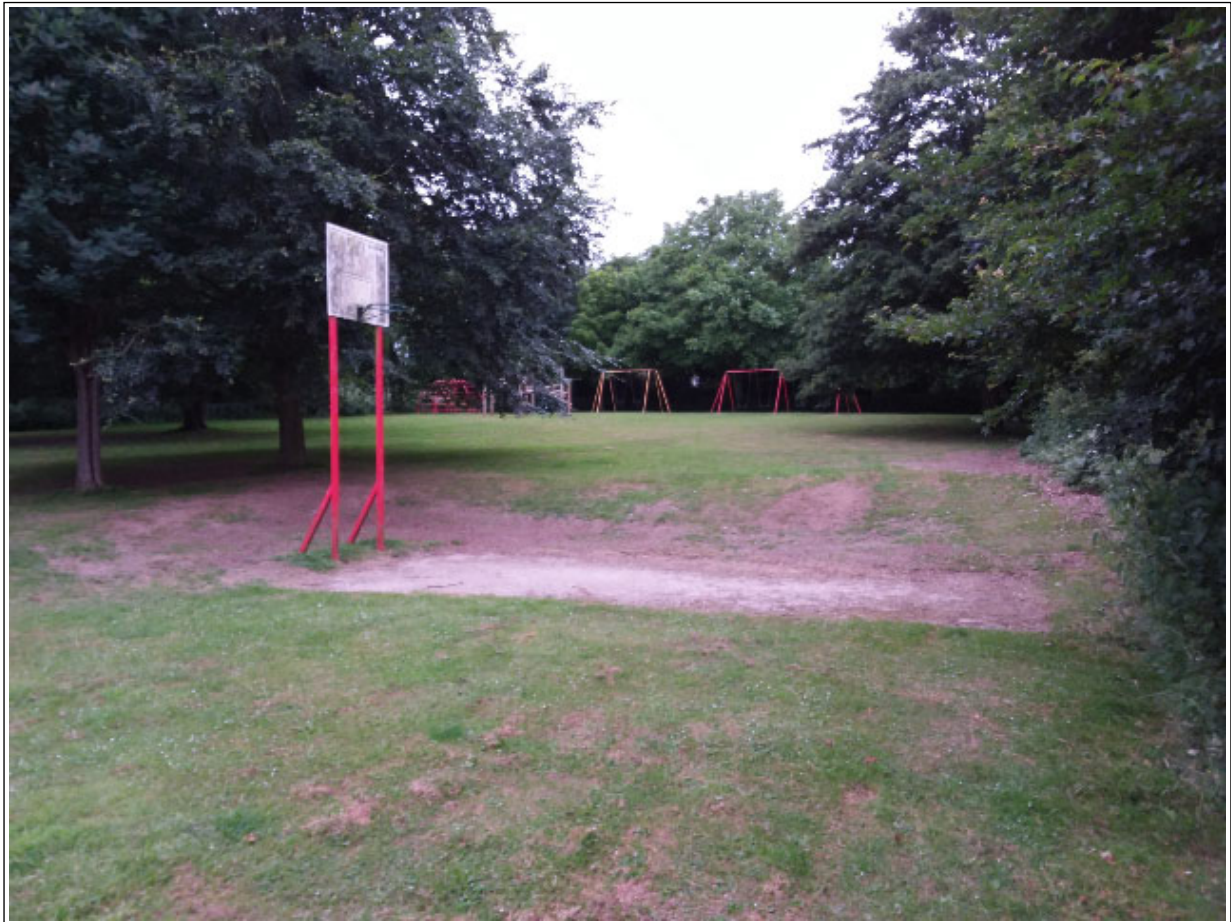
**Location:** The site is located in an area of public open space and is not directly overlooked by any properties in the local community.
